Leak Tests by High-Velocity Impact of Infectious Specimen Containers

CHARLES A. GLICK, B.S., and ARNOLD G. WEDUM, Ph.D., M.D.

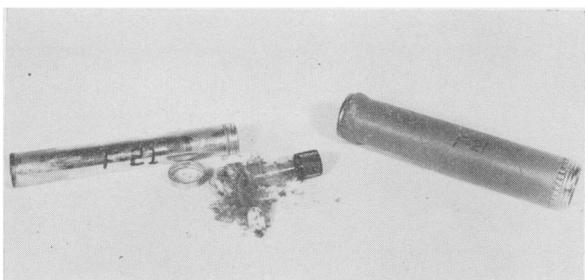
Figure 3. Condition of single tube in F package after impact

F packages. Figure 2 shows the condition of the F packages, containing one test tube each, after impact at an average velocity of 130.2 feet per second (88.77 miles per hour). Figure 3 shows a typical package disassembled after impact. In all except one F package, the small amount of cotton at the top and bottom of the secondary metal container absorbed the 10 milliliters of liquid dye; in one package, the cotton

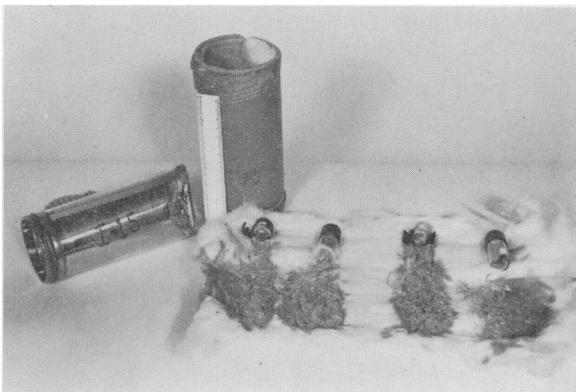
Figure 5. Condition of four tubes in I package after impact

I packages. The condition of the I packages, containing four test tubes each, after impact at 132.8 feet per second (90.54 miles per hour) is shown in figure 4. All the tubes were broken. In several tests the screw caps on one or two tubes were cracked (table 2), but little or none of the contents leaked onto the absorbent cotton. Figure 5 shows a typical package disassembled after impact. None of the dye leaked through the outer fiber container.

condition of the P packages after impact at 130.8 feet per second (89.18 miles per hour) was the same as for the I packages (figs. 4 and 5). All the dye was absorbed by the cotton; none leaked through the outer fiber container.
